AIRFIELD DAMAGE RECOVERY TECHNIQUES OF
18th ENGINEER BRIGADE IN EUROPE (1811)

LTC Theodore Stroup
CPT David Reed
George M. Hammitt

December 1980

Office, Chief of Engineers, U. S. Army
Washington, D. C. 20314

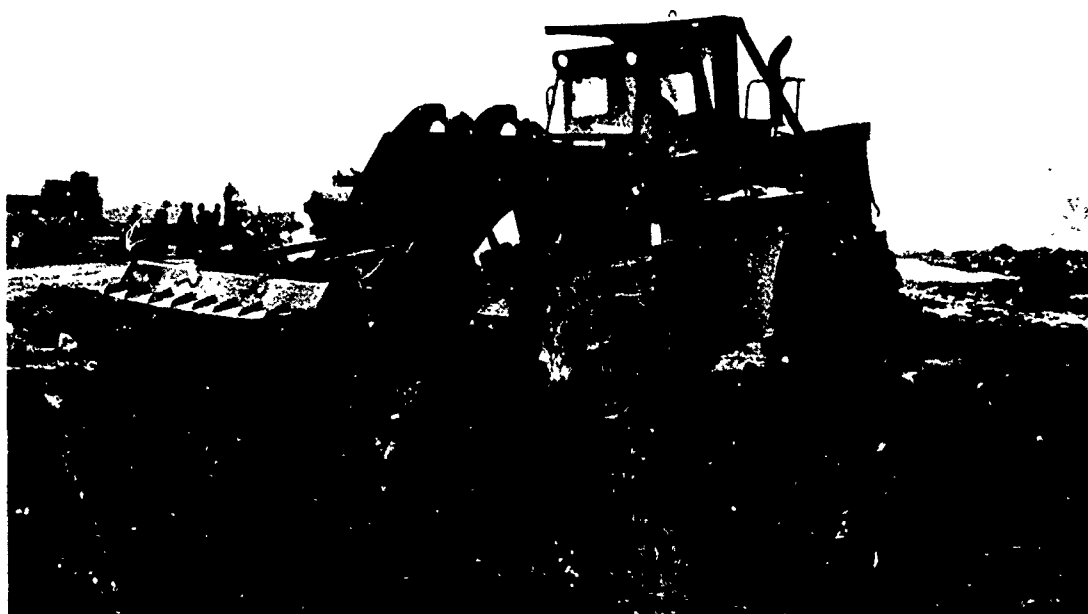
Photo 2

11. Crater 1 was broken open using a wrecking ball dropped from the bucket of a 5-yd loader and a D7 dozer with ripper teeth. A crater approximately 18 ft in diameter and 3 ft deep was constructed. Crater 3 was dug open by a D7 dozer. A crater approximately 75 ft in diameter and 5 ft deep was constructed. Both craters had heaved sections of concrete scattered about the edges as well as "in situ" material spread around the craters (Photo 2). Crater 1 also had approximately 1 ft of standing water in the bottom.

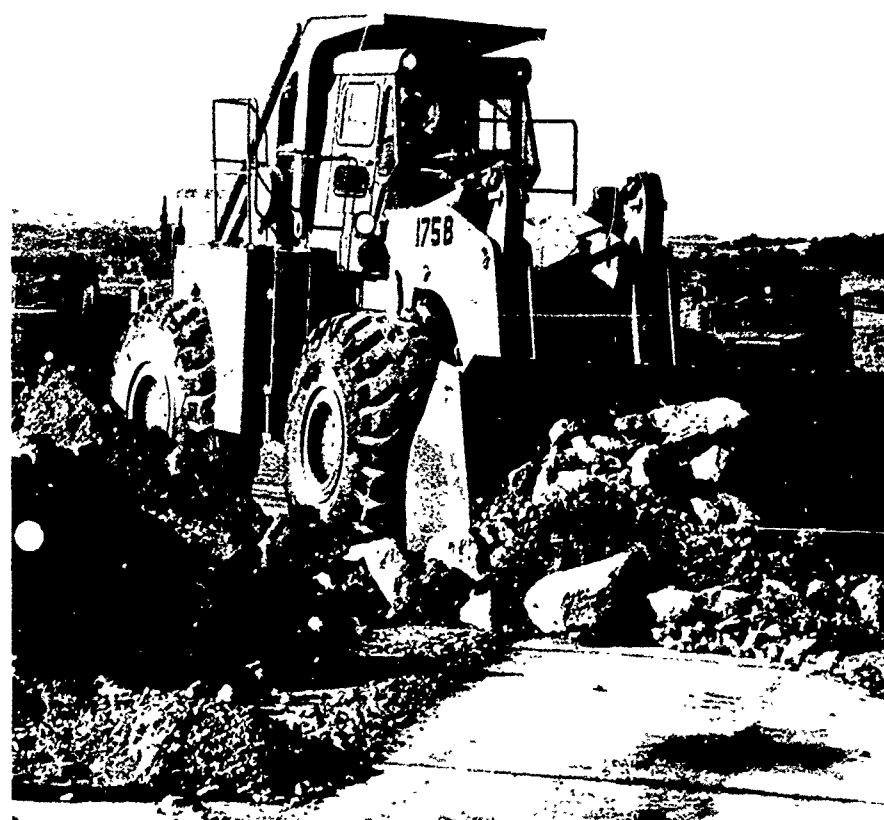
Photo 3

12. Backfilling operations began as soon as the platoon arrived on site at 0845. A 5-yd loader immediately began to push select small ejecta (no size larger than 12 in.) into the crater (Photo 3). Shortly thereafter, a D7 dozer entered the hole to start spreading what the 5-yd

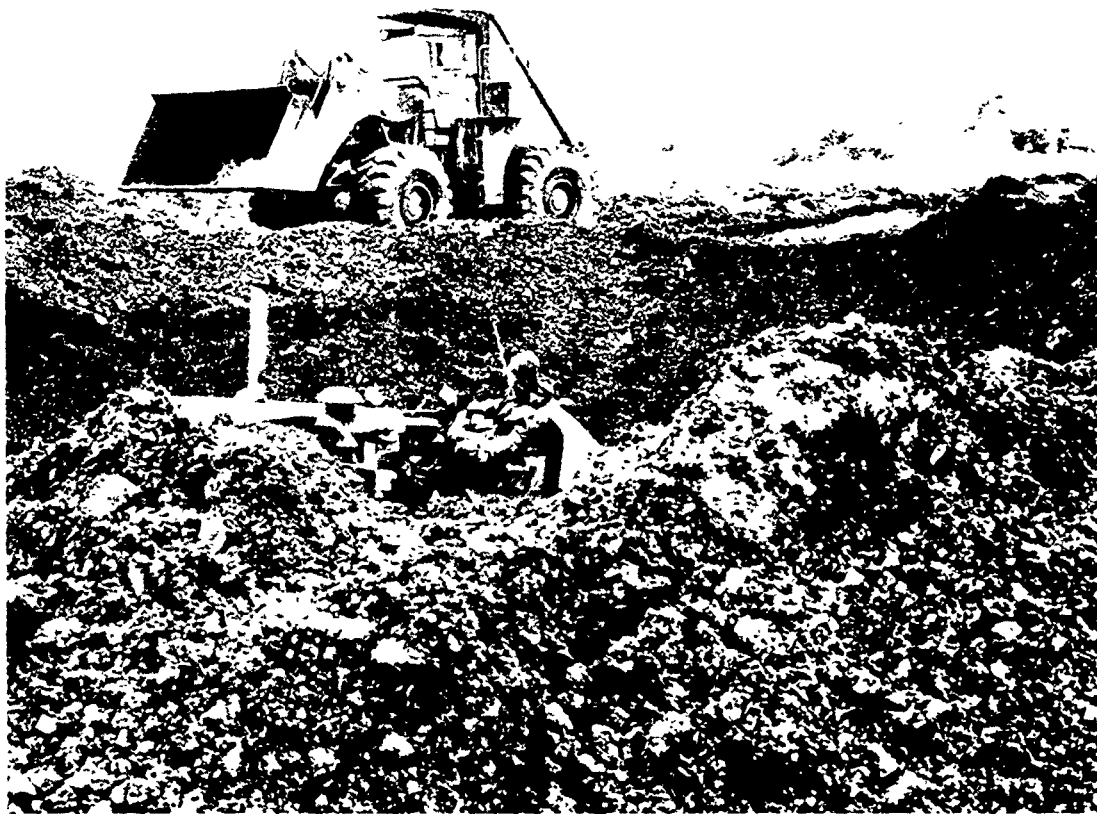
Photo 41

conducted by the advance party using mine detectors, both metallic and nonmetallic. At 1950, just 5 min after the platoon's main element arrived on site, a 5-yd scooploader began to push select small ejecta (no size larger than 0.3 m) into the crater (Photo 41). Shortly thereafter, a D7F dozer entered the crater to start spreading what the 5-yd scooploader pushed in. The D7F dozer also compacted the ejecta by traversing back and forth across the crater as it spread the ejecta (Photo 4). The 5-yd scooploader would also push all large, heaved sections of concrete and unsuitable ejecta to the side of the runway (Photo 5). These two vehicles worked as a team. They completed this task at 2055. The depth below the existing concrete runway surface was now 0.6 m. (This was verified by extending a stringline across the center of the crater and measuring from the stringline to the level of the ejecta.) It must be mentioned here that a Cat 120 road grader assisted the 5-yd scooploader on one side of the crater to push unsuitable ejecta to the side of the runway. This was the platoon leader's idea to see if the operation could be sped up any. Little time was gained, if any, because the 5-yd scooploader finished well before the D7F dozer. Had the grader not assisted, they would have finished together.

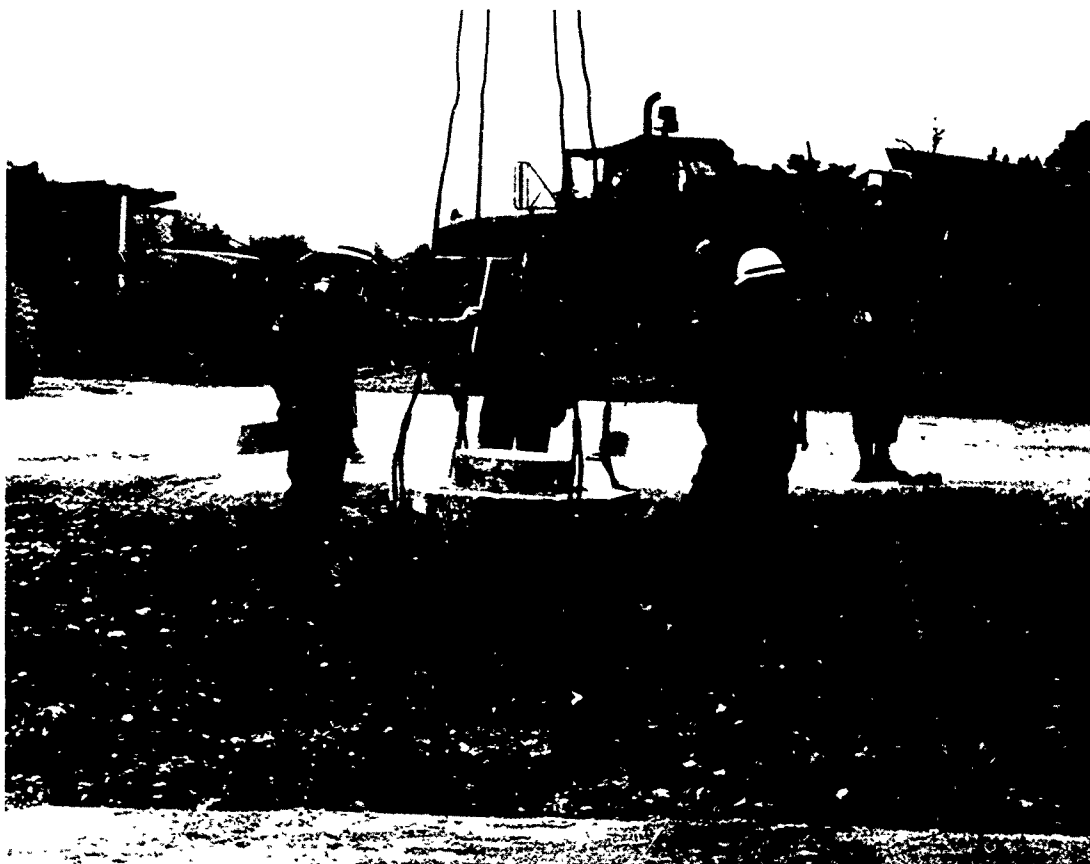
Photo 43

71. Setting pedestal and headwall board. At 1131, a 25-ton P&H crane set the pedestal in place (Photos 43, 44, and 45). It was placed approximately in the center of the crater. The pedestal can be hand carried into place by six persons to speed up the process or if a crane is not available. The pedestal was leveled, and then a round, circular steel bar was placed through the center hole of the pedestal. This bar was used to attach the screed and trail beams to the pedestal. When the pedestal was finally leveled, a headwall board was placed between the pedestal and the outside edge of the crater (Photo 46). The function of this board was to form a wall for the concrete to butt up against so that a head can be created in front of the screed beam. U-shore pickets were driven flush to the top of the board to hold it in place.

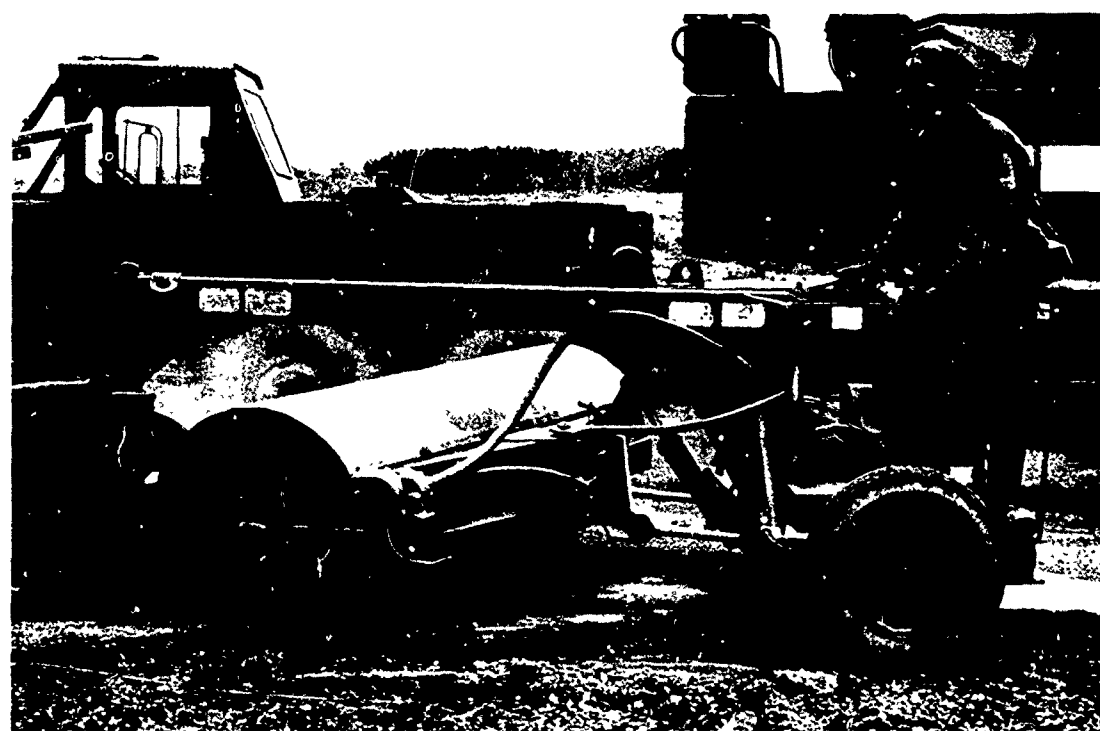
Photo 47

72. Hooking up screed and trail beams. Concurrent with setting the concrete pedestal, other operations were in progress. A rotary sweeper pulled by a jeep was cleaning the area around the crater (Photo 47) while a 250-cfm Davey air compressor was being used to clean the inside

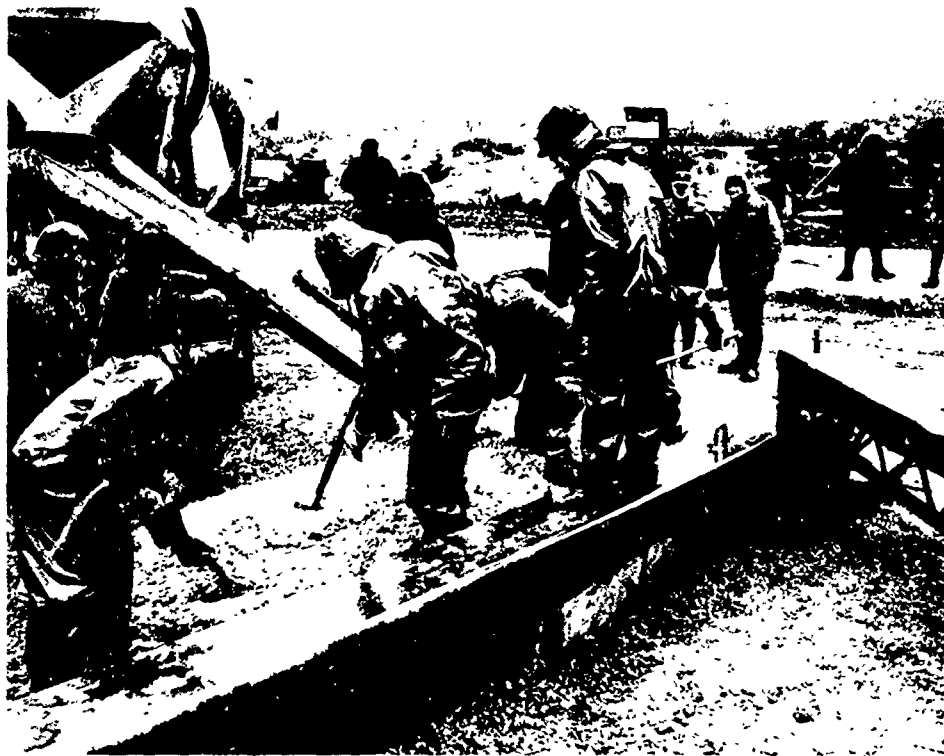
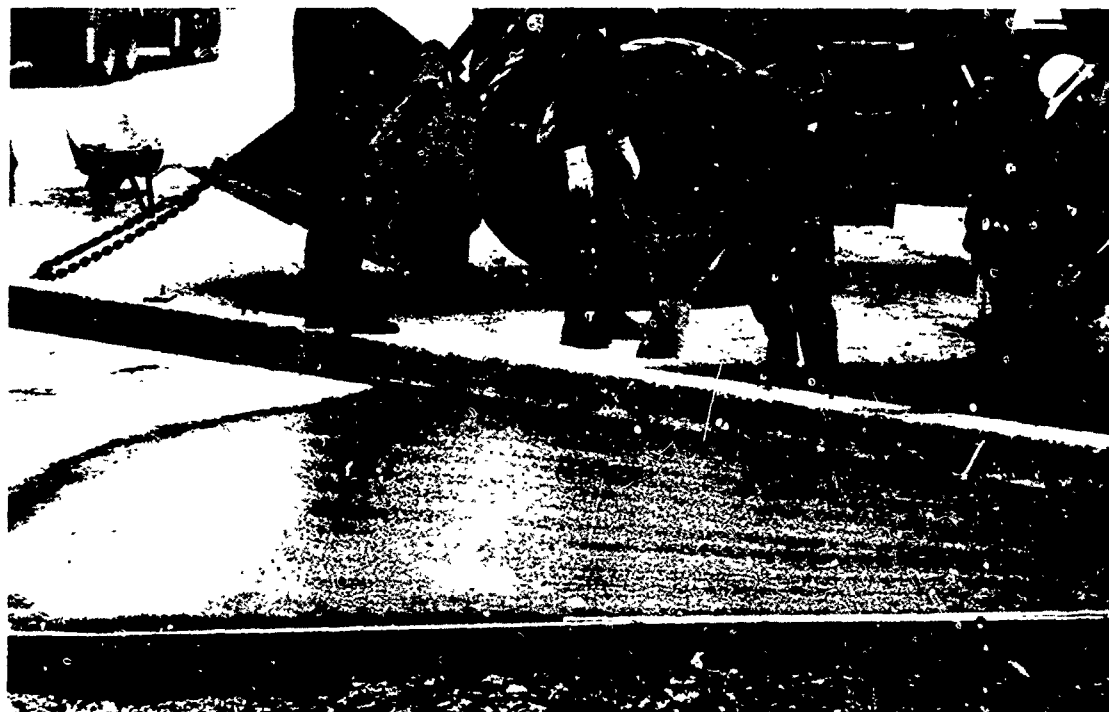
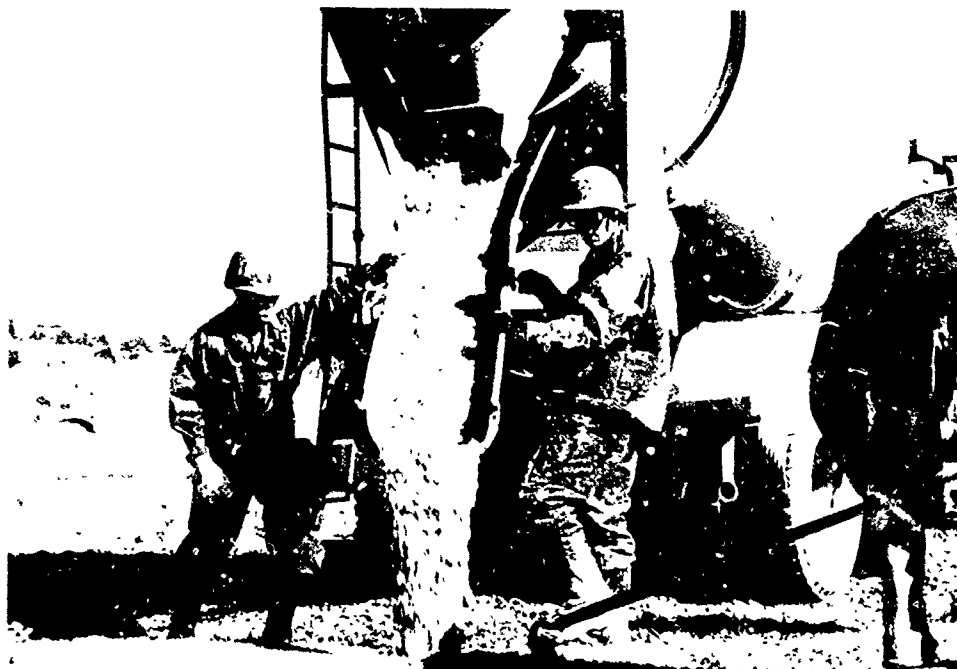
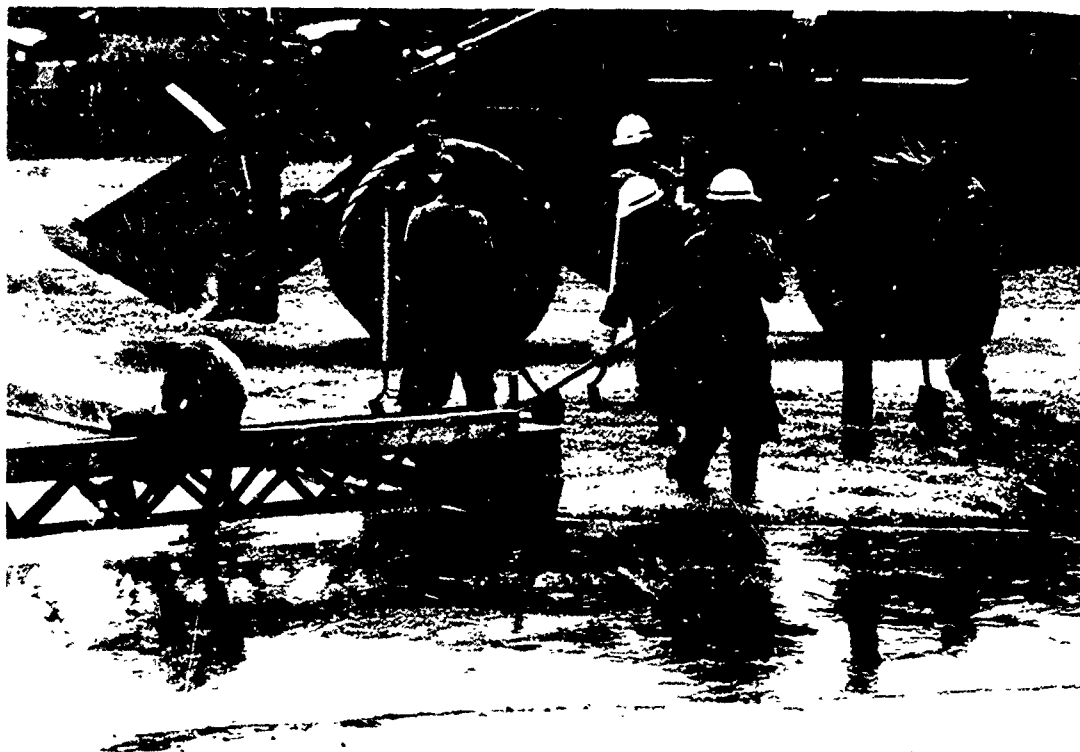
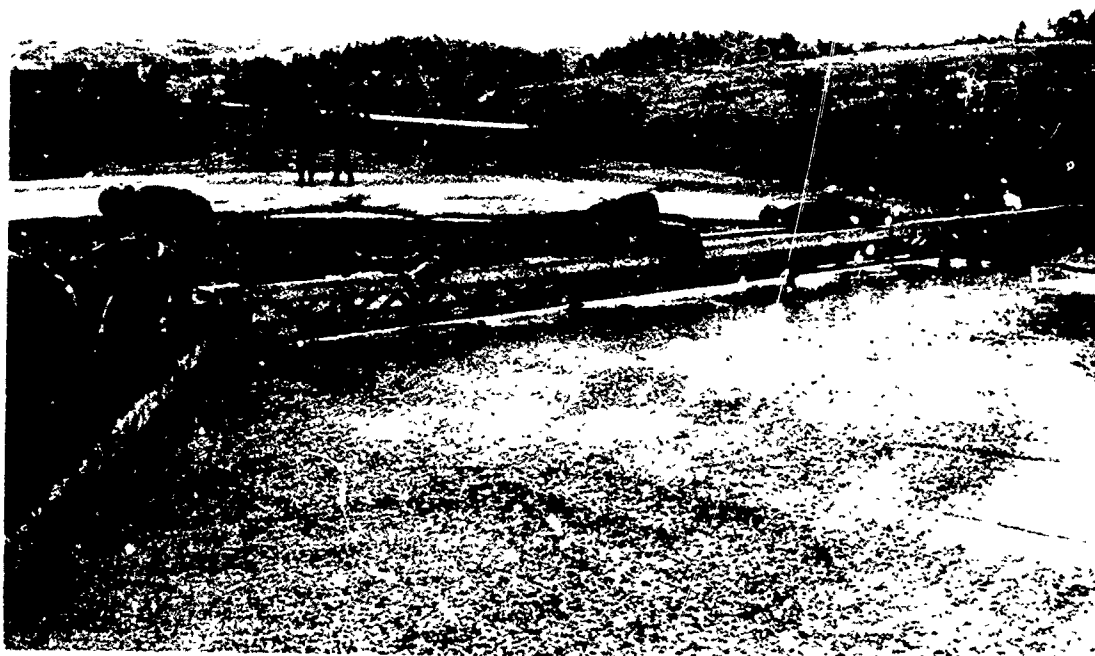
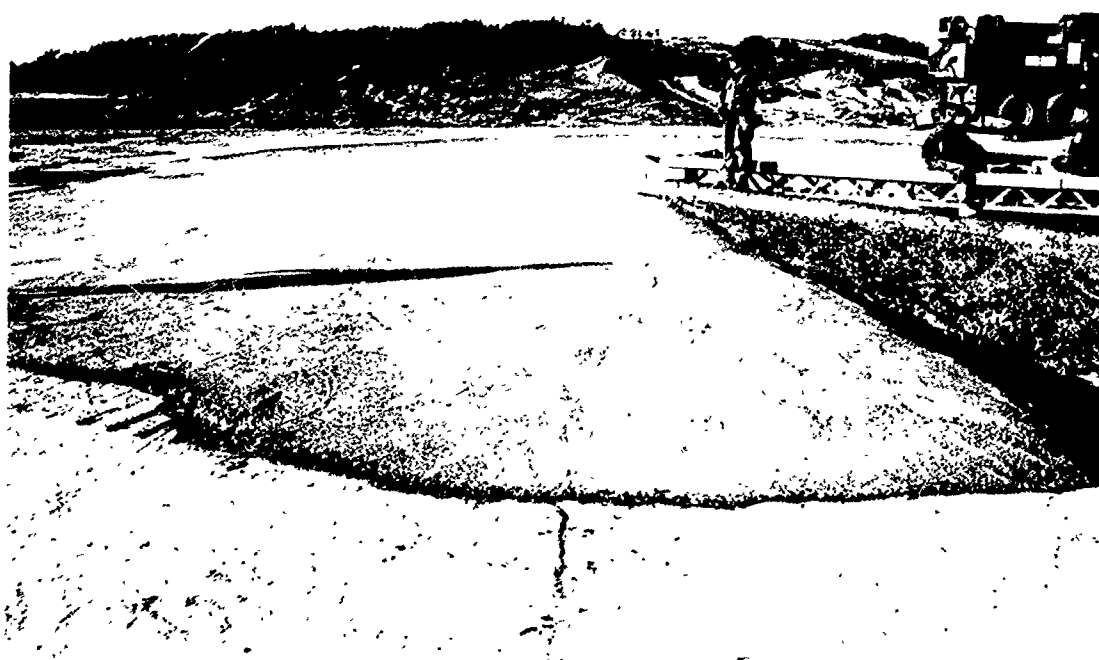
73. Placing concrete. Concrete placement began at 1223. The first truck placed its load directly against the headwall board so that a head could be developed. When enough concrete was placed to build up a head before the screed beam, the screed beam was pulled forward to strike off the concrete flush with the old, existing concrete. This process continued around the crater until all concrete was placed. The last truck of concrete was placed at 1403. (Photos 54 through 65 show views of the technique in process.)

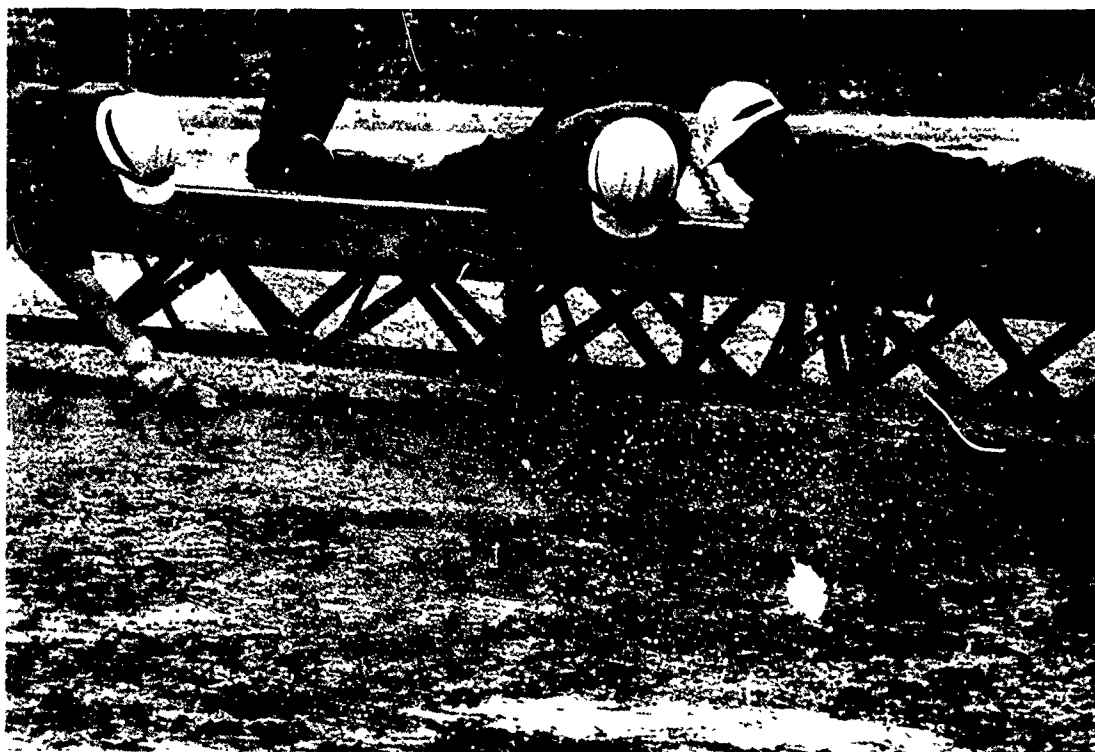
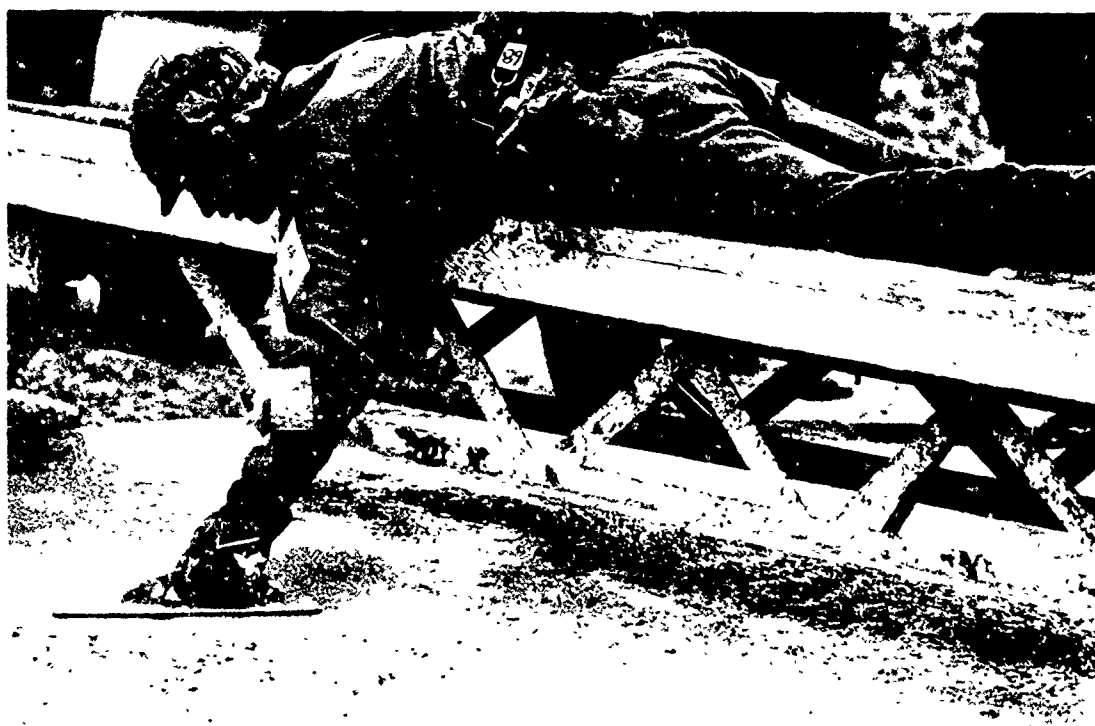
74. Finishing concrete. As previously mentioned, the trail beam is utilized to provide a working platform over the concrete for personnel finishing the concrete surface (Photos 66 and 67). The trail beam in this exercise followed the screed beam by approximately 10-12 ft. As noted in Photo 68, the trail beam is moved by hand because it has wheels that rest on the existing pavement surface. Personnel utilized wooden floats to finish the surface. The edges were also worked with floats to ensure a good bond between the new and existing concrete surfaces. Once the entire surface had been floated, the screed and trail beams were removed by the crane.

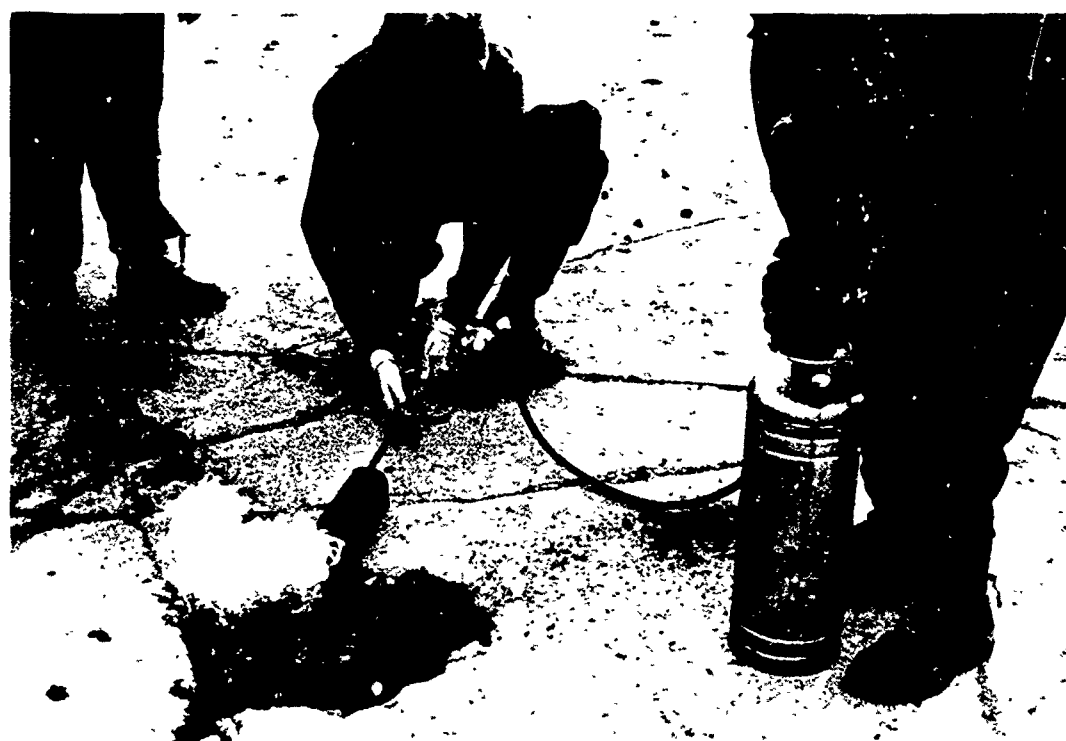
the spall. One man accomplished this with a broom. The spall was then blown clean using compressed air from a Davey 250-cfm air compressor (Photo 69). Finally, the inside surfaces of the spall were dried using a torch (Photos 70 and 71).
